ALI Imagery of Landslide Lake in Pakistan (July 2010)

July 7, 2010
True-Color Image from ALI
Landslide Lake on Hunza
River in Pakistan Overflows
into Spillway

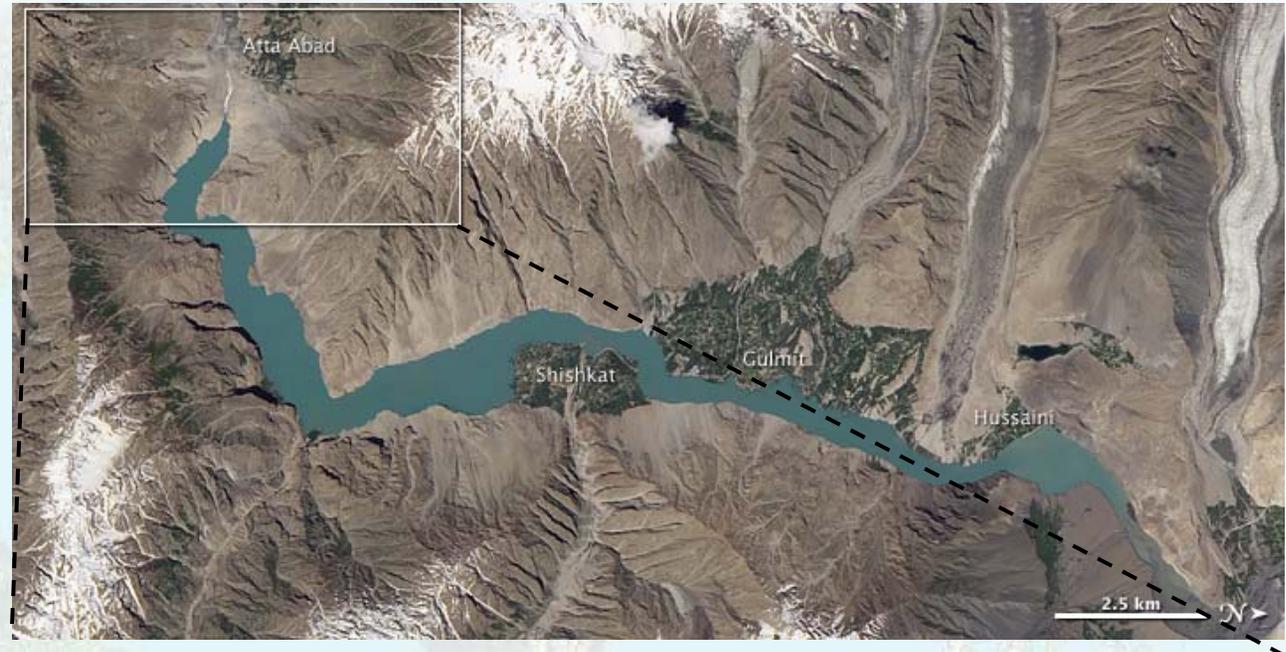
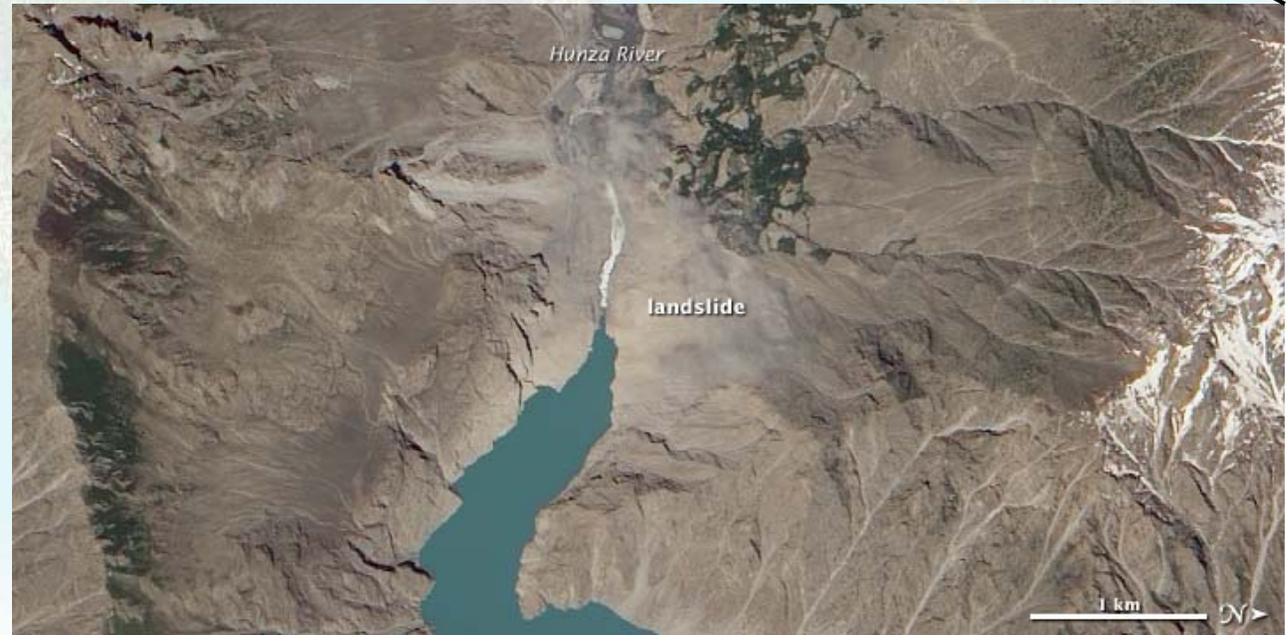
This natural-color image shows the landslide lake and its newly functioning spillway on July 7, 2010. The top image shows a wider view and the bottom image shows a detailed view of the area outlined in white above. North is to the right.

Water pouring over the spillway appears white, likely resulting from its rapid flow. The rest of the lake appears nearly uniform blue-green. Most of the land around the Hunza Valley is brown and bare, but pockets of vegetated land associated with settlements appear near the riverbanks. On the nearby mountaintops, snow cover lingers, and small glaciers snake toward the river valley.

Along the Hunza River in northwestern Pakistan, a lake had been building for months behind a landslide dam that formed in January 2010. Engineers and army laborers worked furiously on a spillway to relieve the growing lake, which had backed up past several settlements. In late May 2010, the lake finally began flowing over the spillway. According to geologist David Petley at the International Landslide Centre, lake levels had apparently stabilized by July 6.
