ALI Imagery of a Large Landslide in Uganda (Mar. 2010)

March 11, 2010
True-Color Image from ALI
Large Landslide in Uganda

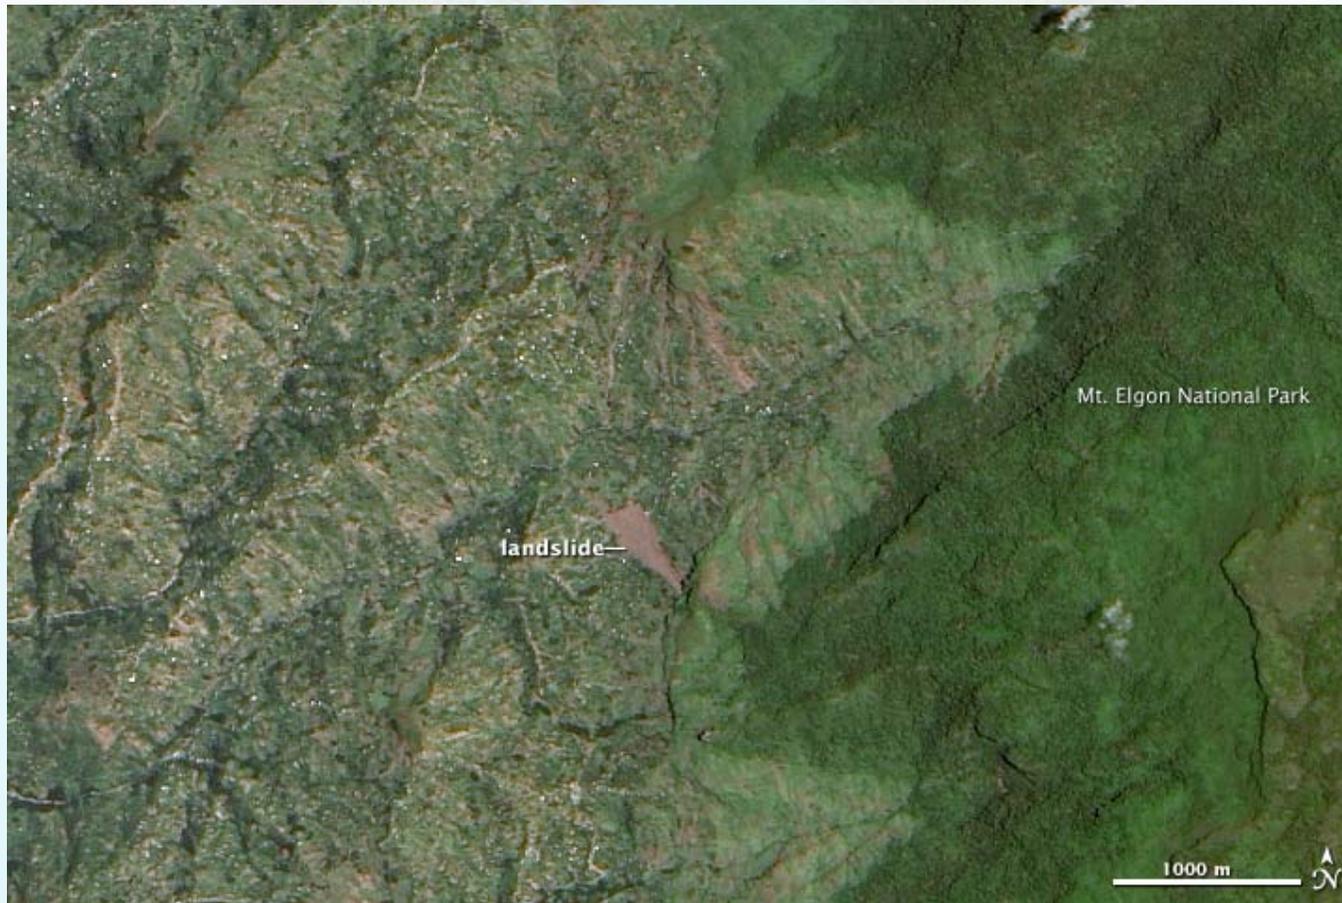
Heavy rains triggered these landslides on the steep slopes of Mt. Elgon in Uganda, on March 1, 2010. The newly exposed earth is slightly pink, raw compared to other patches of bare ground, which are lighter brown. As the older scars hint, landslides are common in the region, but the new landslides are much larger than previous slides. The slides buried three villages, leaving 83 dead and more than 300 missing.
